### **FATAL ACCIDENT REPORT**

## **LONE MOUNTAIN PROCESSING, INC. CLOVER FORK NO. 1**

**FALL OF RIB**

**STATE FILE NO. 18549**

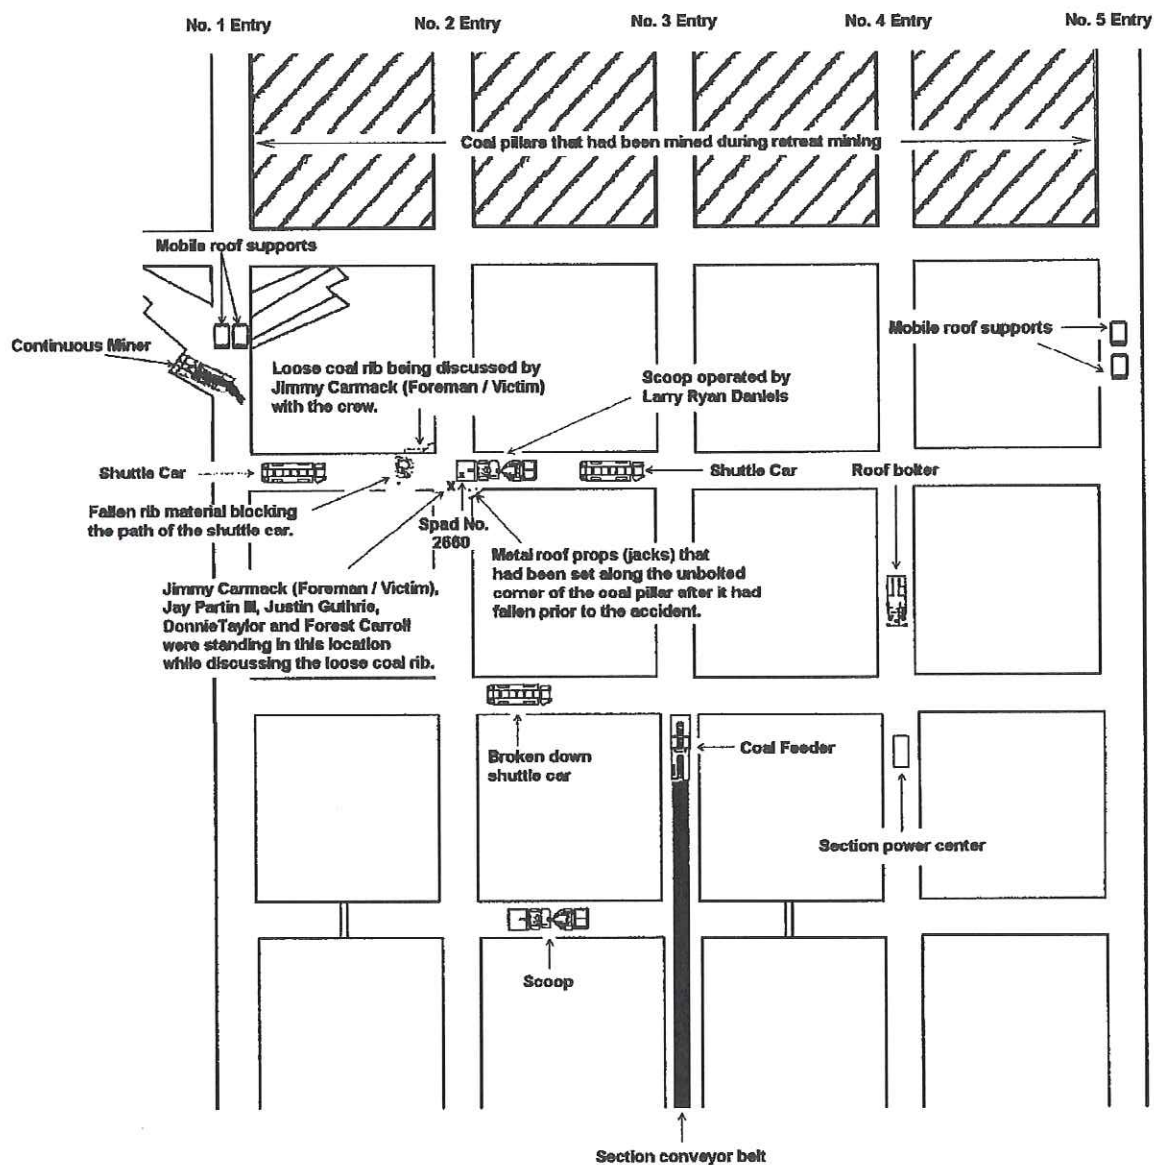
**Sketch No. 1  
Before The Accident  
Not To Scale**

The coal rib on the outby corner of the No. 2 right crosscut had fallen sometime prior to the occurrence that caused the accident and the rib had not been re-bolted. There had been three (3) metal Heintzmann Corporation roof props (jacks) set near the corner to correct the wide area created by the first rib fall. Two (2) of the roof jacks were set along the right rib of the entry and the jack (that struck the victim) had been set on the corner.

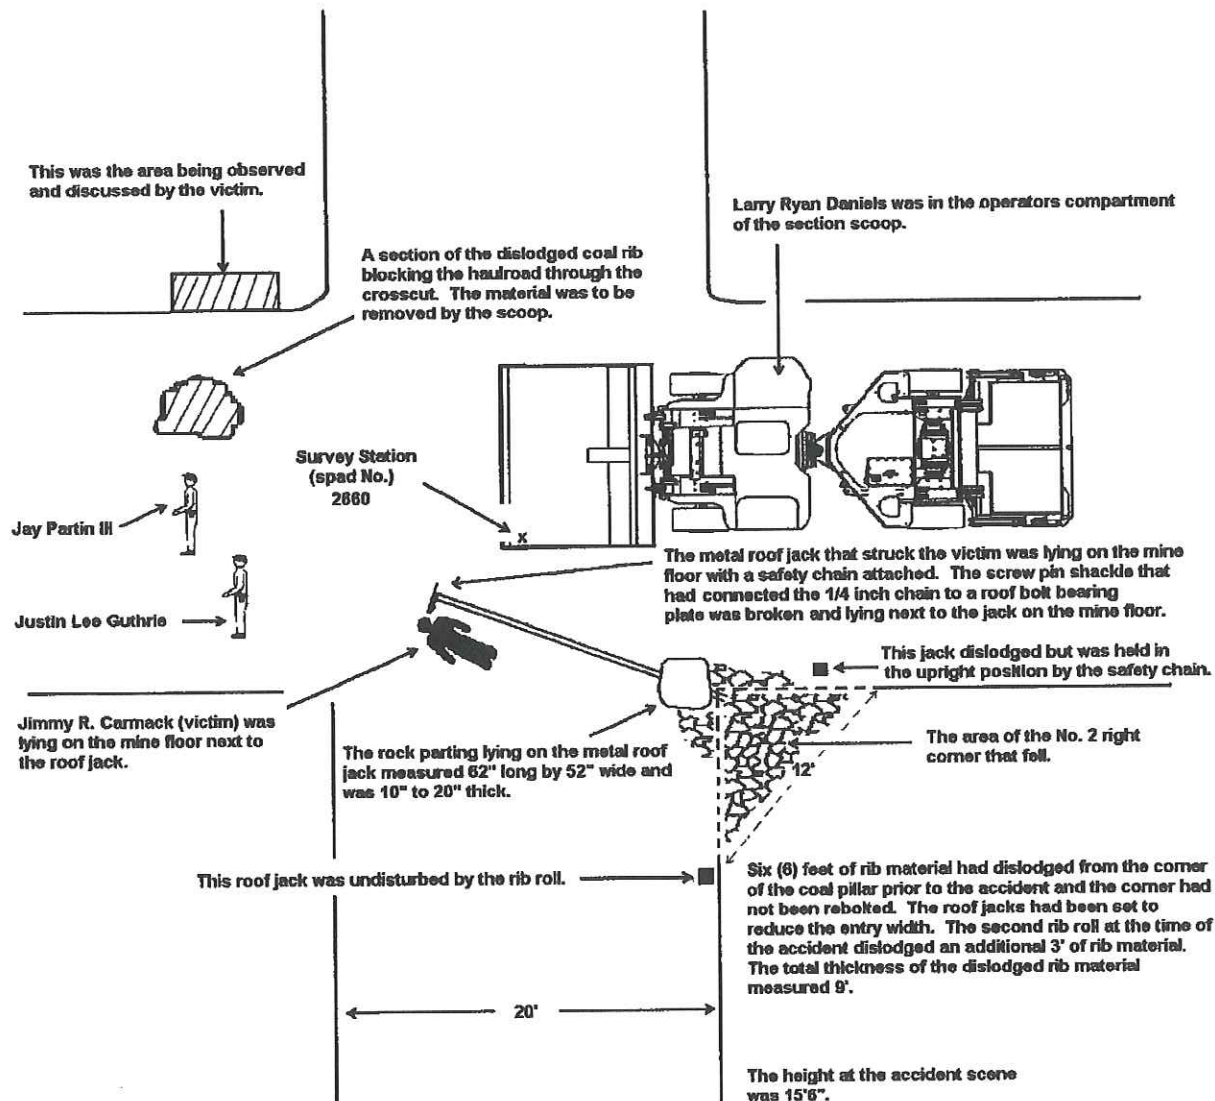
**Sketch No. 2**  
**After The Accident**  
**Not To Scale**

The corner of the right coal rib had dislodged, fell and struck a standing roof jack and the jack struck Carmack as it fell to the mine floor.

During the accident, two (2) of the three (3) roof jacks dislodged. The fallen roof jack that struck the victim was extended to a length of one hundred and ninety-four and one-quarter ( $194\frac{1}{4}$ ) inches. A mark on the jack indicated that while it was set, it had been extended to a length of one hundred and eighty-nine and one-half ( $189\frac{1}{2}$ ) inches. An eight by eight (8 x 8) inch metal base was present at the top and bottom of the jack. The roof jack had been tightened against the roof with a wooden cap board.

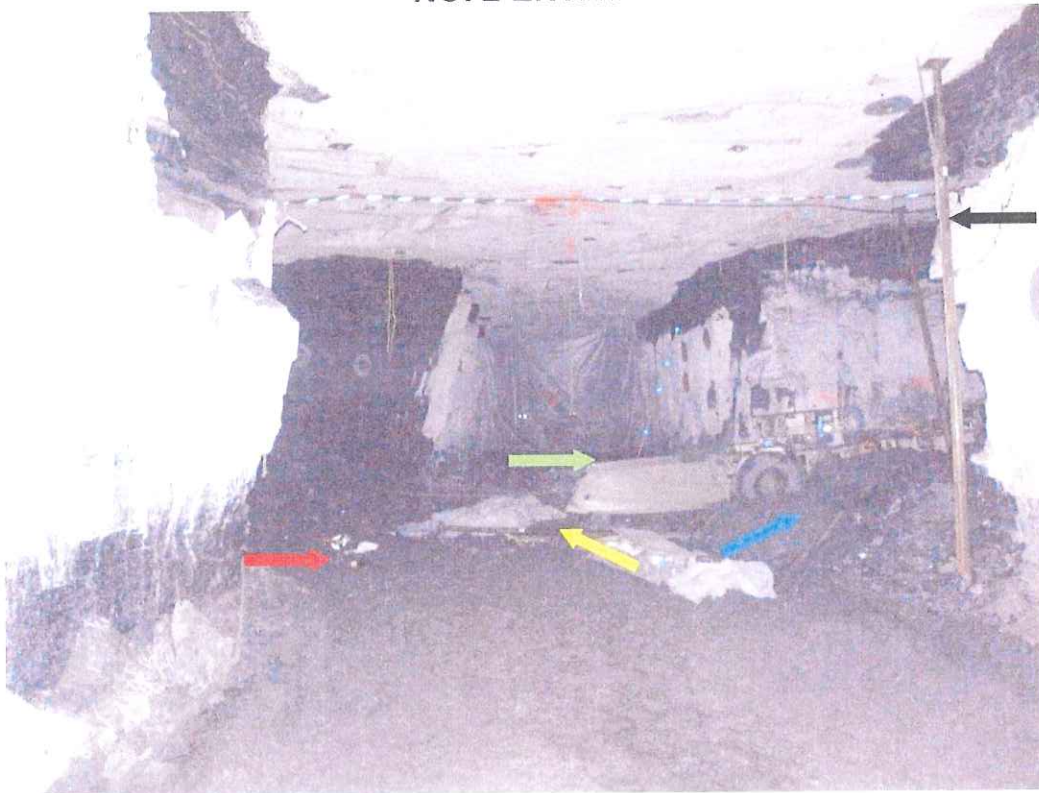
**ACCIDENT SCENE  
NO. 2 ENTRY**

**RED ARROW INDICATES THE APPROXIMATE LOCATON  
OF THE VICTIM, JIMMY R. CARMACK**

**BLACK ARROW INDICATES AN UNDISTURBED ROOF JACK**

**YELLOW ARROW INDICATES THE ROOF JACK THAT WAS DISLODGED,  
FELL AND STRUCK THE VICTIM**

**BLUE ARROW INDICATES THE RIB MATERIAL (COAL AND ROCK)  
THAT FELL FROM THE CORNER OF THE PILLAR**

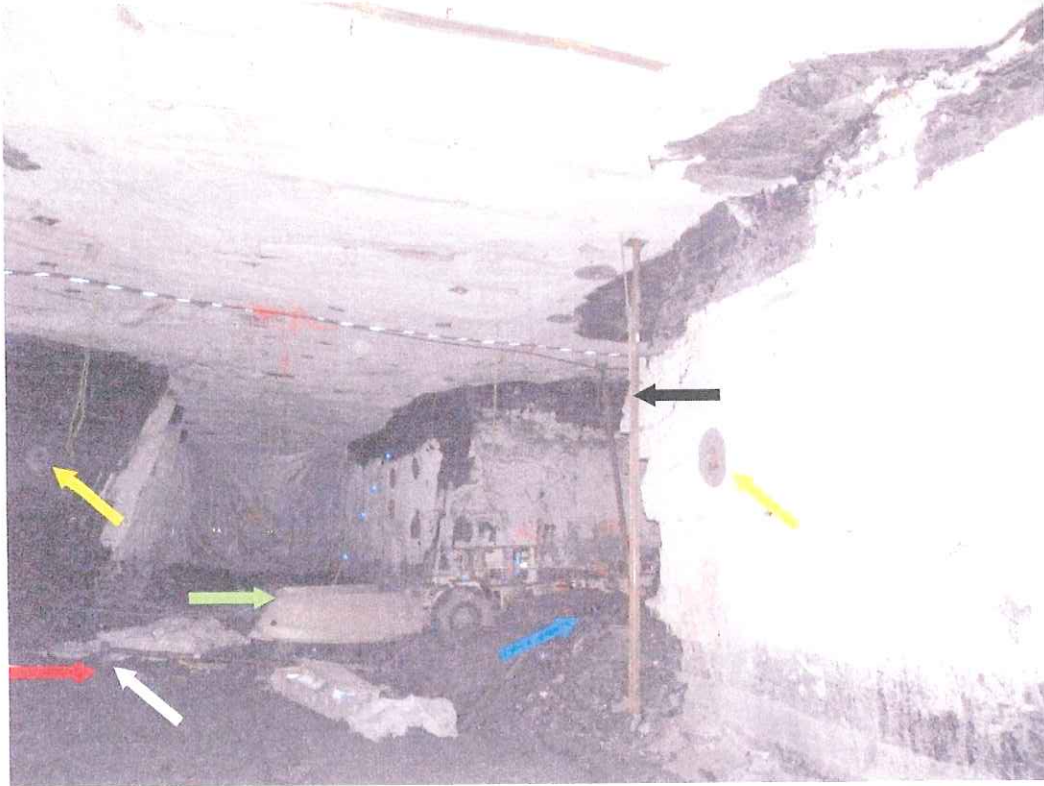
**ACCIDENT SCENE  
NO. 2 ENTRY**

**RED ARROW INDICATES THE APPROXIMATE LOCATON  
OF THE VICTIM, JIMMY R. CARMACK**

**BLACK ARROW INDICATES AN UNDISTURBED ROOF JACK**

**WHITE ARROW INDICATES THE ROOF JACK THAT WAS DISLODGED,  
FELL AND STRUCK THE VICTIM**

**BLUE ARROW INDICATES THE RIB MATERIAL (COAL AND ROCK)  
THAT FELL FROM THE CORNER OF THE PILLAR AND DISLODGED THE JACK**

**YELLOW ARROWS INDICATE RIB SUPPORT (ROOF BOLTS)**

- 1. Prior to the accident, the roof control plan did not require the coal ribs to be bolted, however, when mining the Owl and Darby seam simultaneously, the coal ribs shall be supported and maintained.**
- 2. Examine roof and rib conditions and correct any hazards prior to entering the work area.**
